Arlington Housing Authority
Building Envelope Repairs, Window Replacement, Phase 1
Winslow Towers 667-3, Elderly Housing
Schematic Report and Recommendations

Re: Winslow Towers Condition Assessment - DRAFT
WJE No. 2017.6855

Wiss, Janney, Elstner Associates, Inc. (WJE) completed a facade condition assessment and performed diagnostic water penetration testing at the Arlington Housing Authority (AHA) property Winslow Towers located at 4 Winslow Street in Arlington, Massachusetts. This letter is intended to serve as a summary of our observations and provide recommendations for short and long-term repairs.

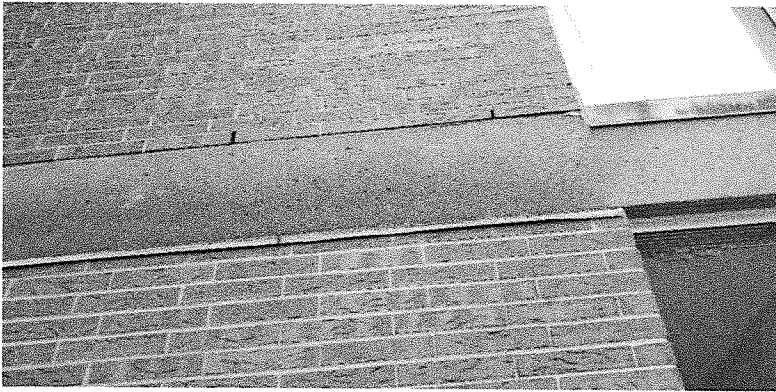
- Through wall flashings were observed at the floor line joint at the brick masonry bed joint as well as above the top course of brick at the joint below the perimeter beam soffit (Figure 5). Locations of observed flashing do not match original drawings, the flashing does not appear to have a drip edge, except at the bottom of the concrete beams, making it very difficult to locate accurately. Weeps were observed approximately every third brick at the floor line flashing.

Figure 5. Typical floor line perimeter beam with exposed flashing

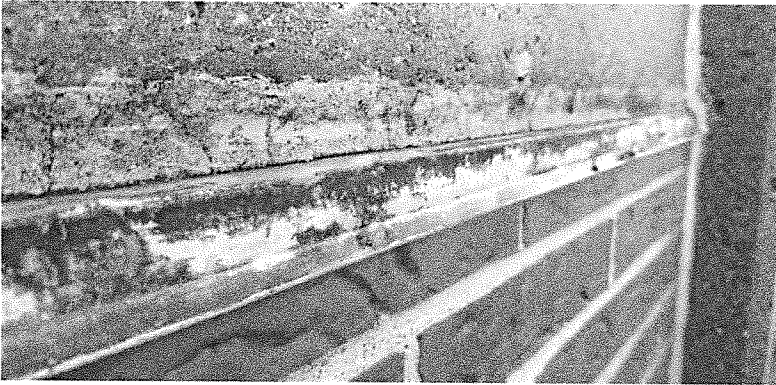
- Cracked mortar, bond line separation, and organic growth are typical at the mortar joint between the brick infill and the bottom of the exposed concrete beams (Figure 5).

Figure 6. Cracked mortar and organic growth at mortar joint between brick and concrete perimeter beam soffit

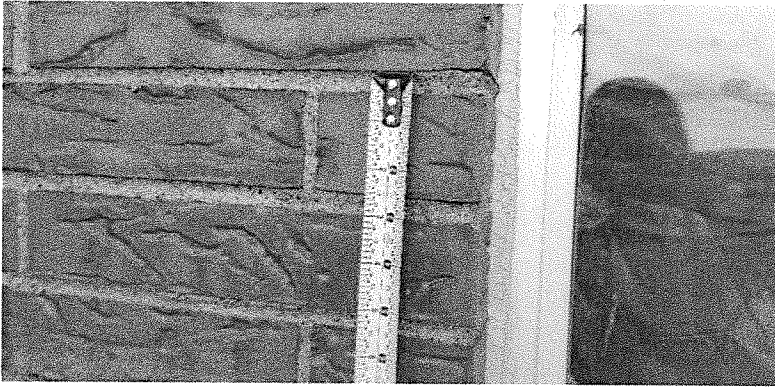
Figure 7. Typical mortar joint

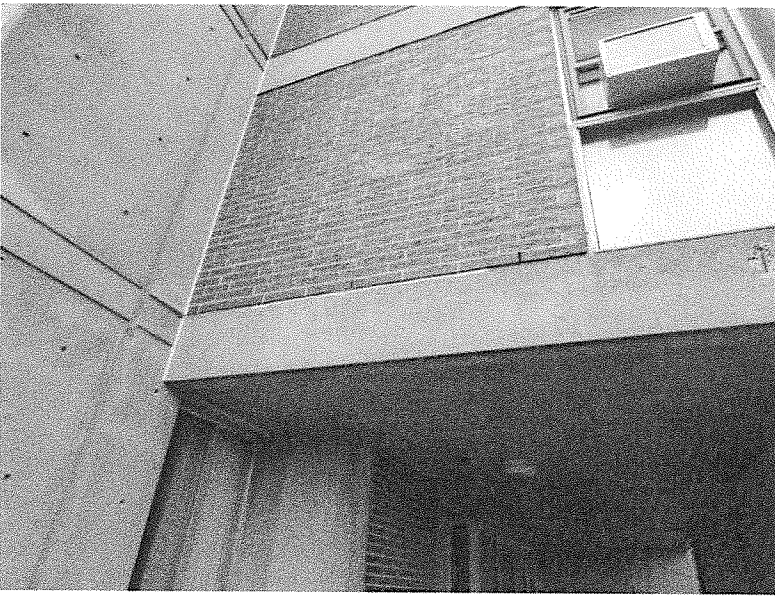
Figure 8. Sealant installed over mortar

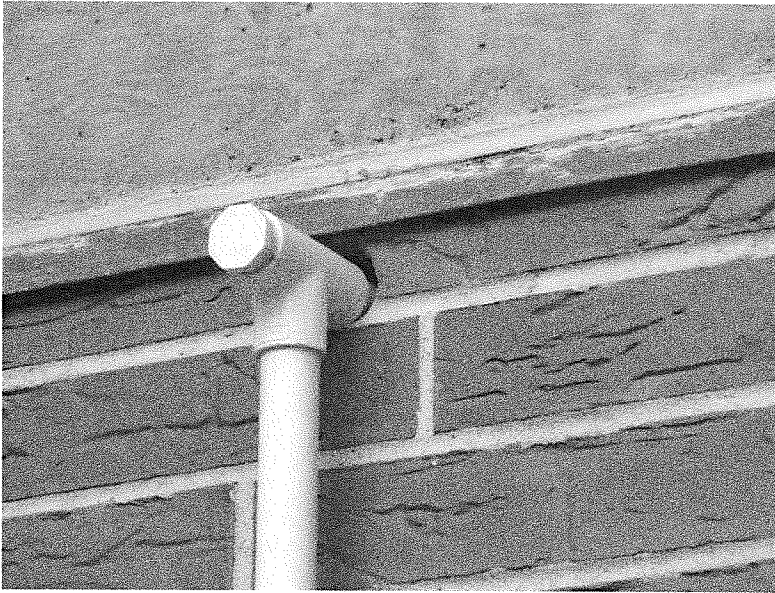
Figure 9. Unsealed PVC pipe penetration at the east facade, first floor

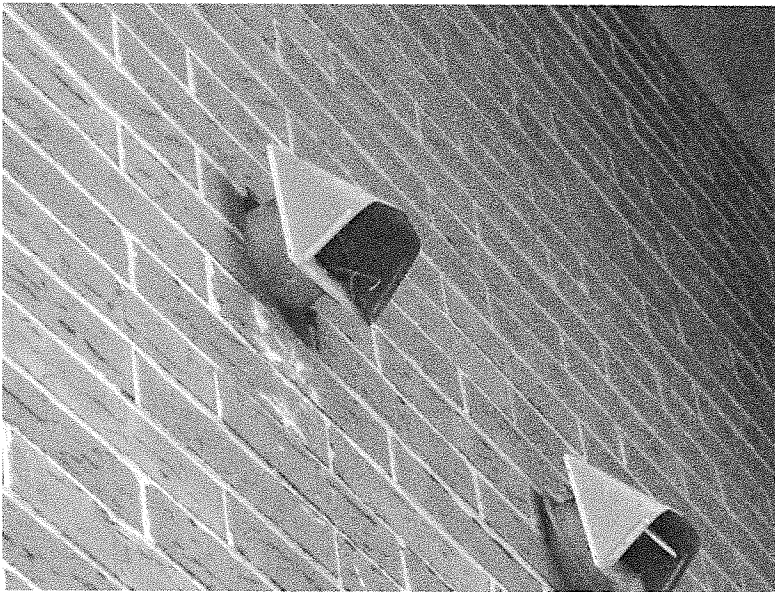
Figure 10. Bird's nest in unsealed vent

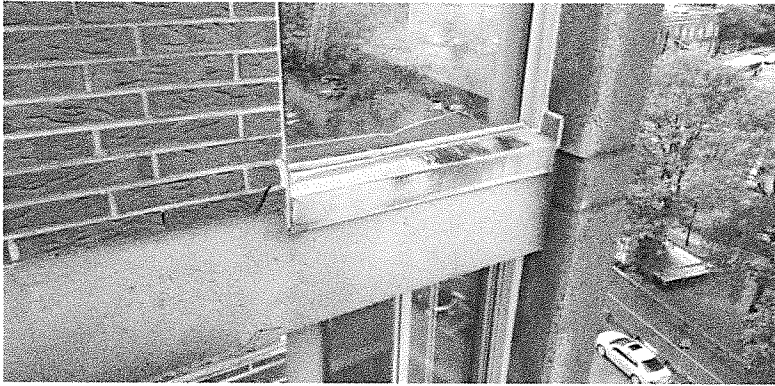
- One cracked brick was noted at the west facade adjacent to an eleventh-floor window (Figure 11).
- There are areas of organic growth and discoloration at the west facade (Figure 12).

The cracked brick adjacent to an eleventh-floor window is of greater concern as it appears during water testing to be a source of the water infiltration observed at Unit 1102. Unsealed penetrations are also a concern as they may allow excess water to enter more directly into the interior of the building resulting in water infiltration and damage to interior finishes. AHA did not report to WJE leaks at the first floor associated with unsealed penetrations.

Figure 11. Cracked brick at west facade, eleventh floor

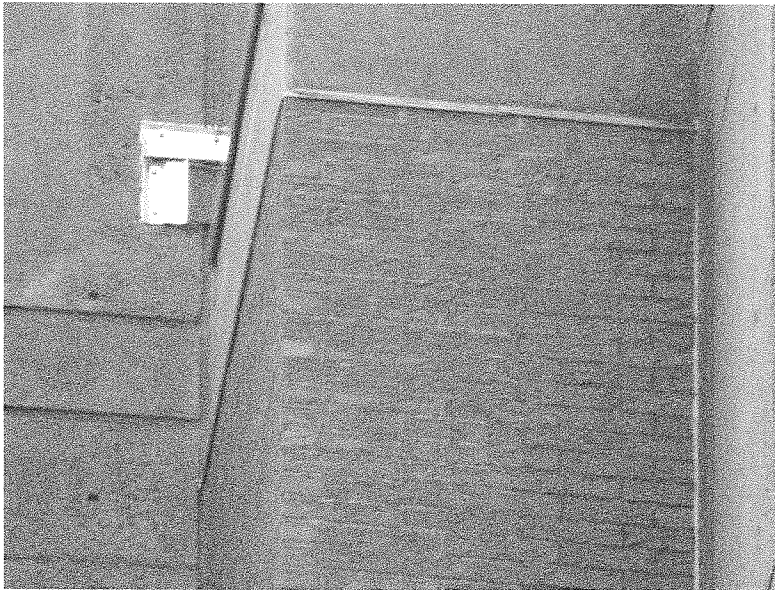
Figure 12. Organic growth and discoloration of brick at west facade

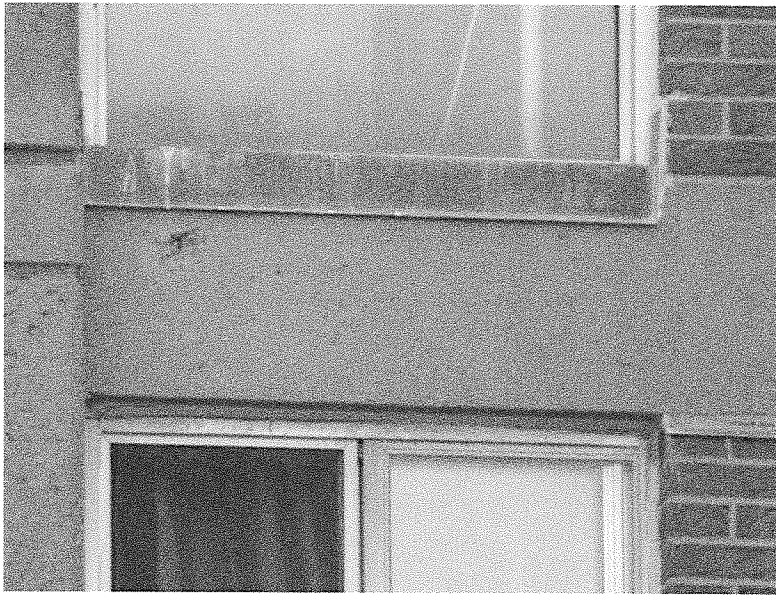
- There are multiple concrete spalls at perimeter beam at each facade (Figure 13). Shallow concrete cover (less than 1 inch), exposed, corroded reinforcing bars are typical at spall locations (Figure 14).
- One large spall (approximately 1 SF) was removed at the west facade during the close-up inspection (Figure 15).
- Incipient spalls are typical at perimeter beams, columns, and concrete shear walls at all facades (Figure 16 and Figure 17).
- Incipient spalls at all facades and concrete elements are most often observed at previous repair locations (Figure 18 and Figure 19). Previous repairs do not follow accepted industry practice for concrete repairs and have irregularly shaped perimeters and feather edging of the cementitious repair mortar.
- There is a 2 foot long vertical crack at the east facade (Figure 20)

Figure 13. Typical concrete spall at west facade perimeter beam

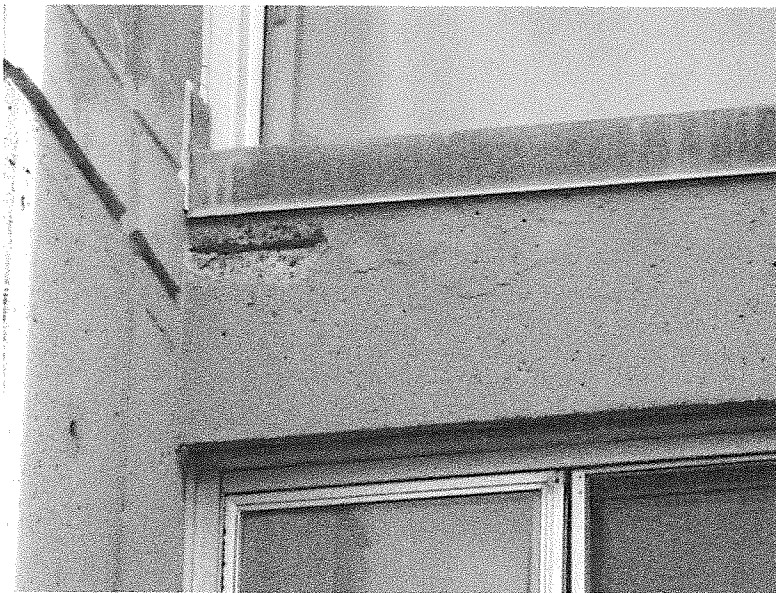
Figure 14. Exposed and reinforcing bar at concrete spall and adjacent delaminated concrete at south facade

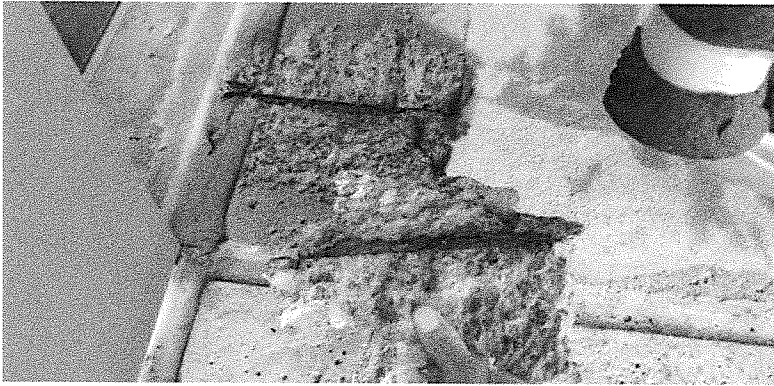
Figure 15. Large spall at west facade

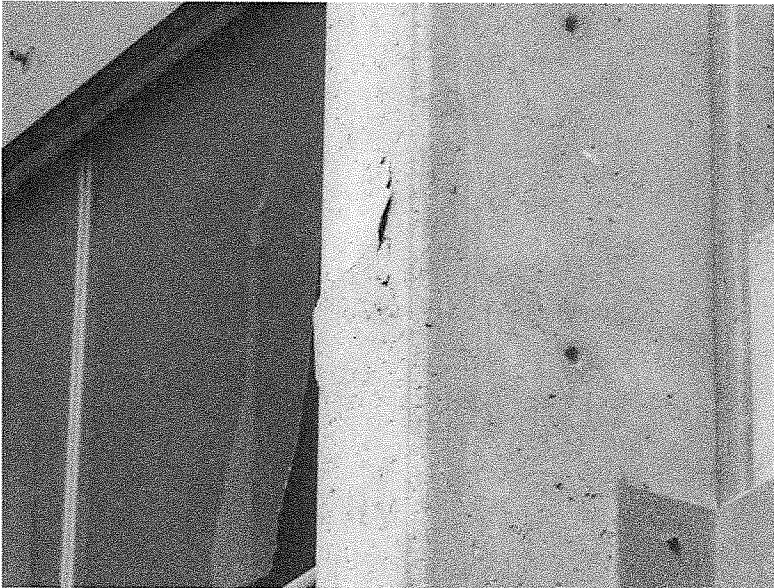
Figure 16. Incipient spall at concrete shear wall at south facade

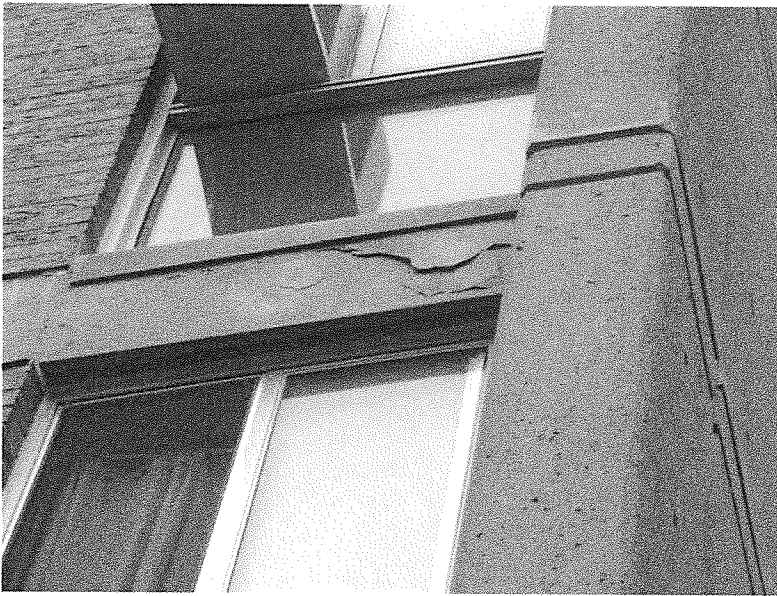
Figure 17. Incipient spall at concrete perimeter beam at east facade

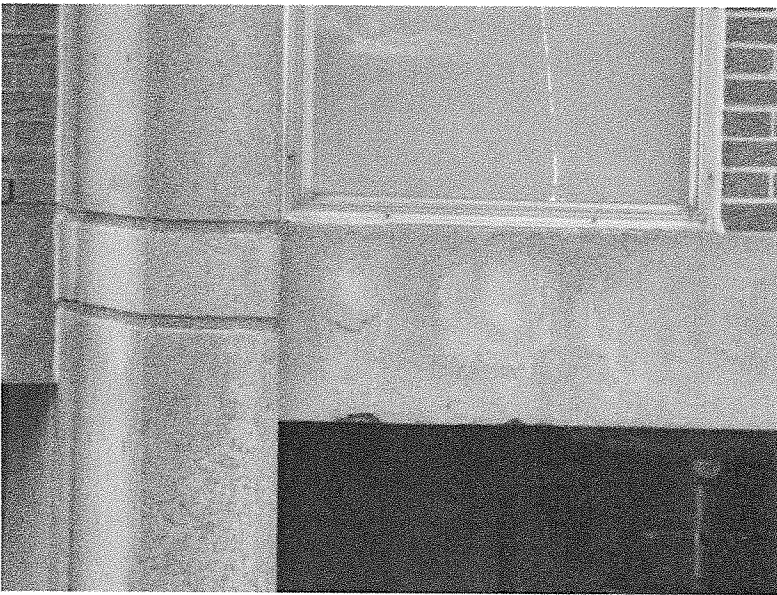
Figure 18. Incipient spall at repaired area at west facade

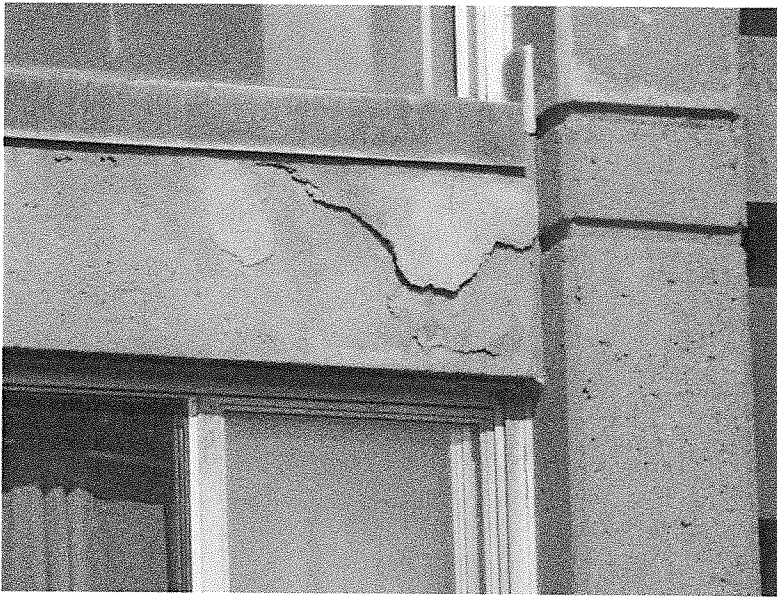
Figure 19. Incipient spall at repaired area at east facade

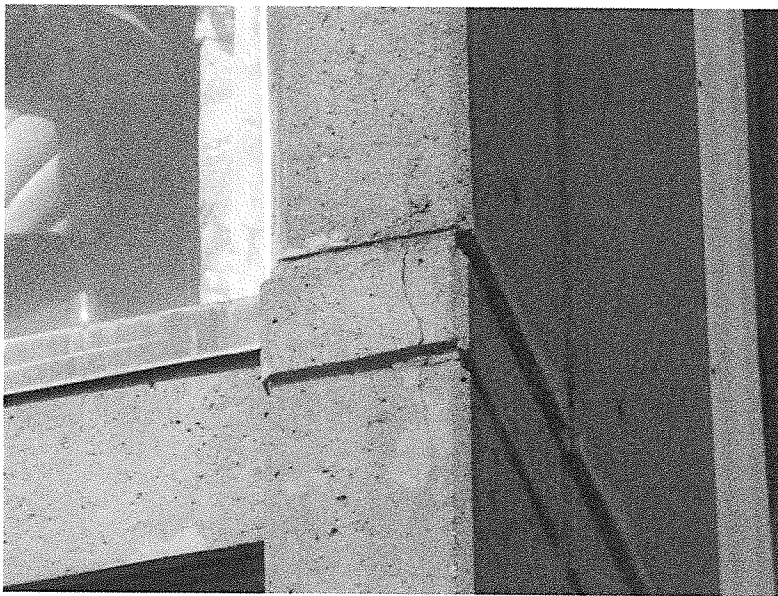
Figure 20. Large crack in concrete at east facade

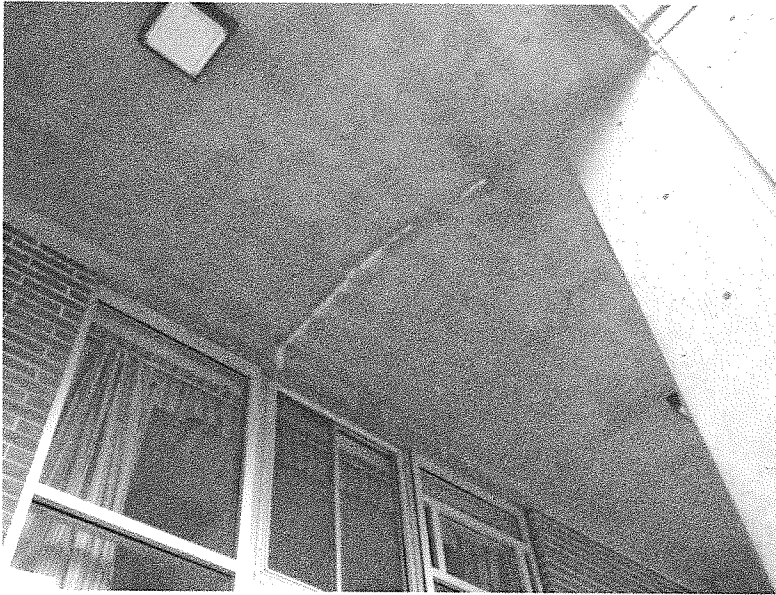
- There is a crack along the second floor soffit at the east facade. There is also efflorescence along the crack (Figure 21).
- There are several holes and unsealed penetrations at the facades, in particular at the first floor (Figure 22, Figure 23).
- At multiple locations, there are displaced pieces of wood that appear to have been used originally to form the drip edge above the window and were never removed (Figure 24).

Figure 21. Crack with efflorescence at east facade

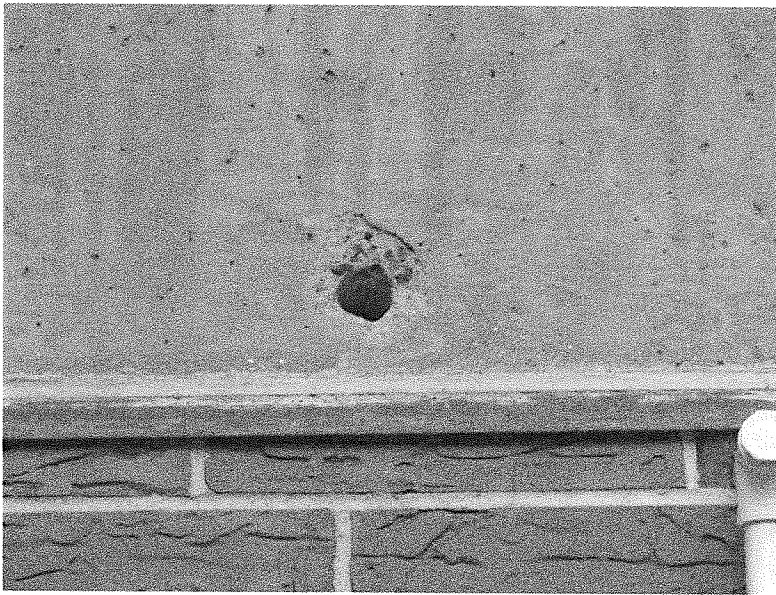
Figure 22. Unsealed hole at east facade, first floor

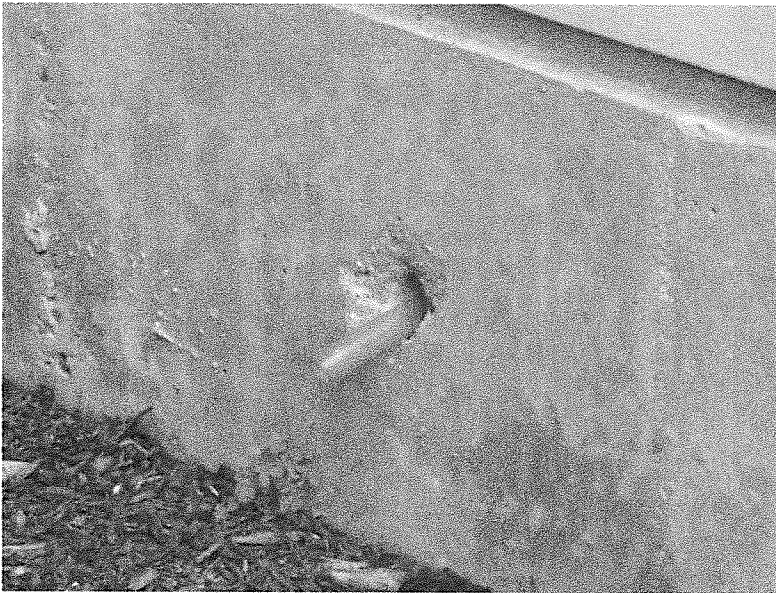
Figure 23. Unsealed penetration at east facade, first floor

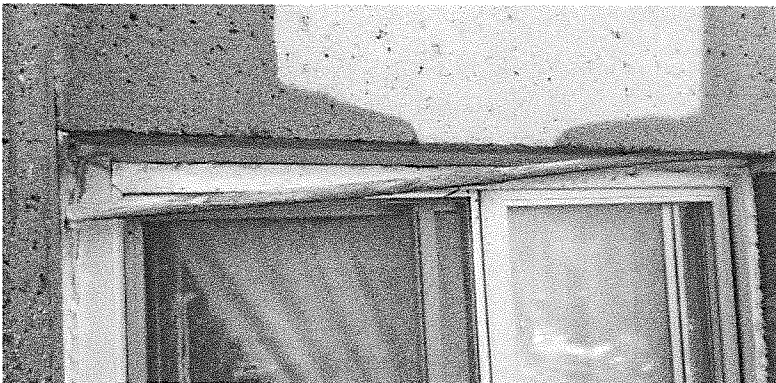
Figure 24. Displaced wood coming from drip edge above window at west facade

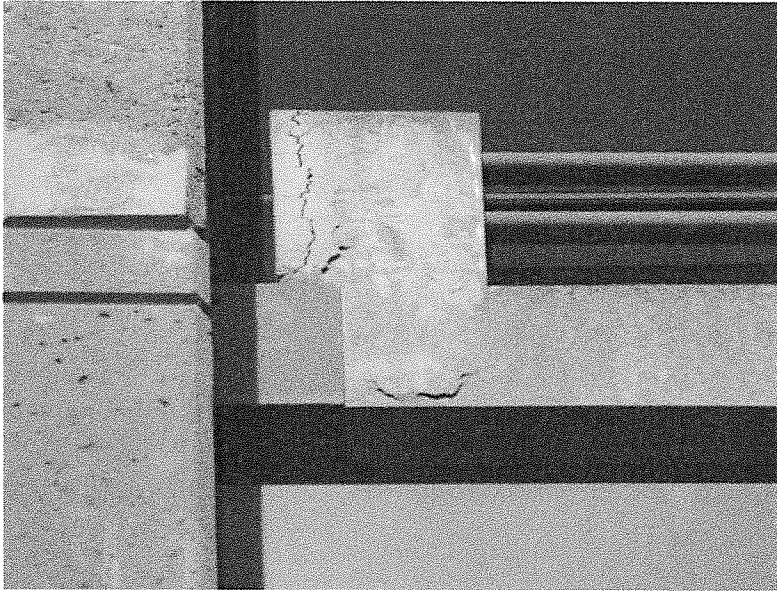
- There are multiple incipient spalls at the exterior of one tenth-floor precast concrete balcony rail (Figure 25).
- There is an incipient spall at the exterior of a third-floor balcony rail (Figure 26).
- There is a spall at the bottom of one tenth-floor balcony rail (Figure 27).
- Concrete cracking was noted at the interiors of balcony rails at three Units surveyed. Cracking, where observed, was typically adjacent to embedded anchor locations (Figure 28)
- Organic growth is typical at the face of precast concrete balcony rails at the north, east, and west facades (Figure 29).
- Dirt and staining was observed at many of the balcony decks adjacent to drains at the edge of the balcony (Figure 30).

Figure 25. Incipient spalls on concrete balcony rail at east facade, tenth floor

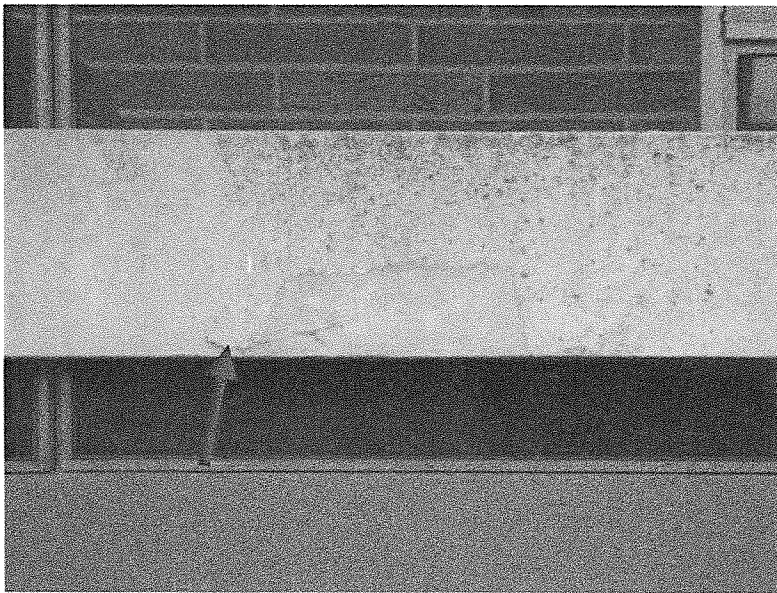
Figure 26. Incipient spall on balcony rail at west facade, third floor

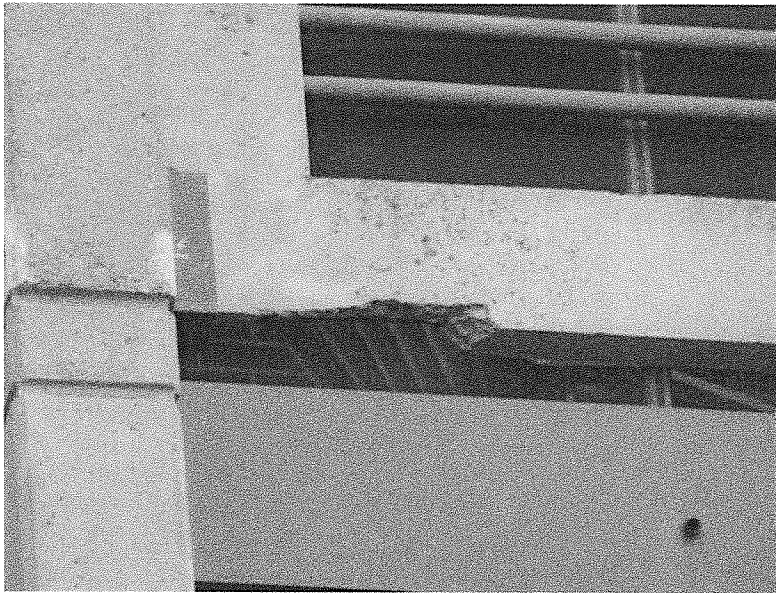
Figure 27. Spall at bottom of concrete balcony rail at south facade, tenth floor

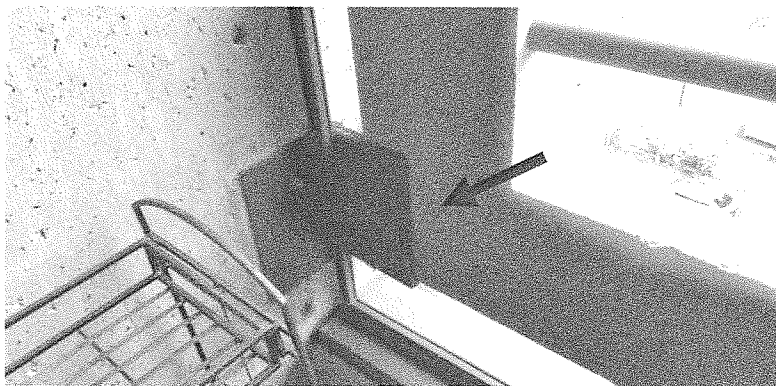
Figure 28. Concrete cracking next to anchor at balcony rail interior

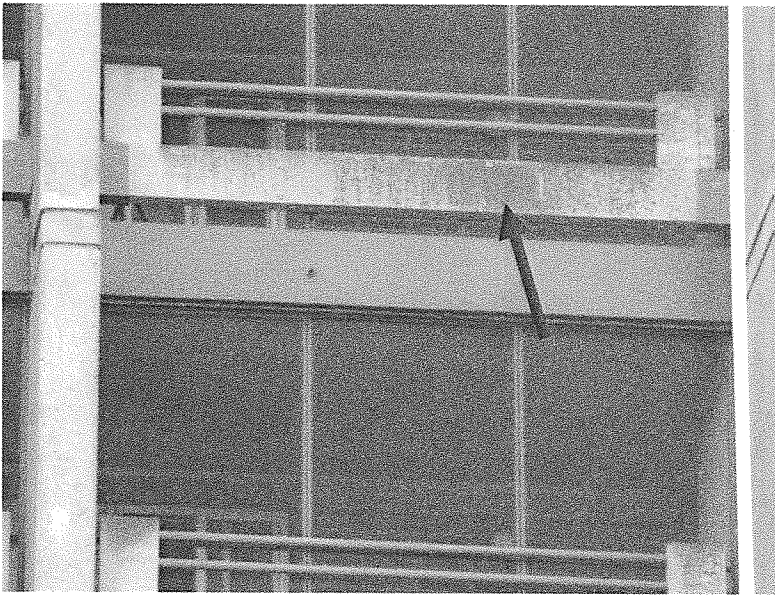
Figure 29. Organic growth on precast concrete balcony rails at west facade

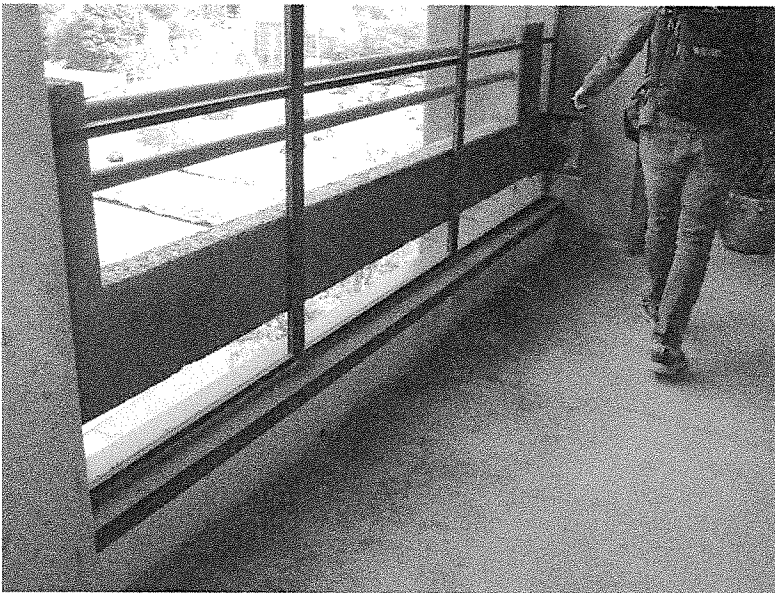
Figure 30. Typical dirt at balcony adjacent to drains

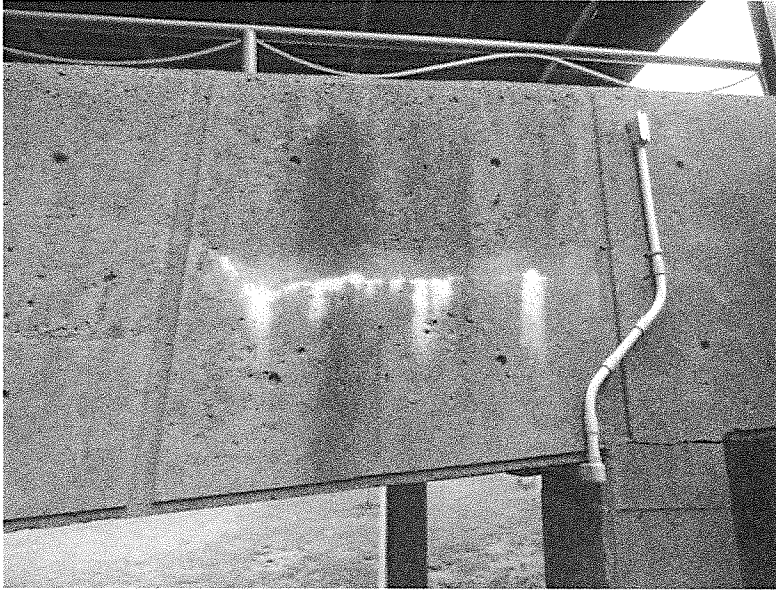
- There are concrete cracks with efflorescence along the west side of the bridge (Figure 31).
- Cracks with efflorescence and corrosion staining are typical at the underside of the bridge (Figure 32 and Figure 33).
- There are incipient spalls at multiple locations at the bridge soffit (Figure 34).
- A large crystalline deposit has developed at an electrical penetration location (Figure 35).
- One of the drain pipes under the bridge is fractured (Figure 36).

Figure 31. Cracks in concrete with efflorescence at west side of pedestrian bridge

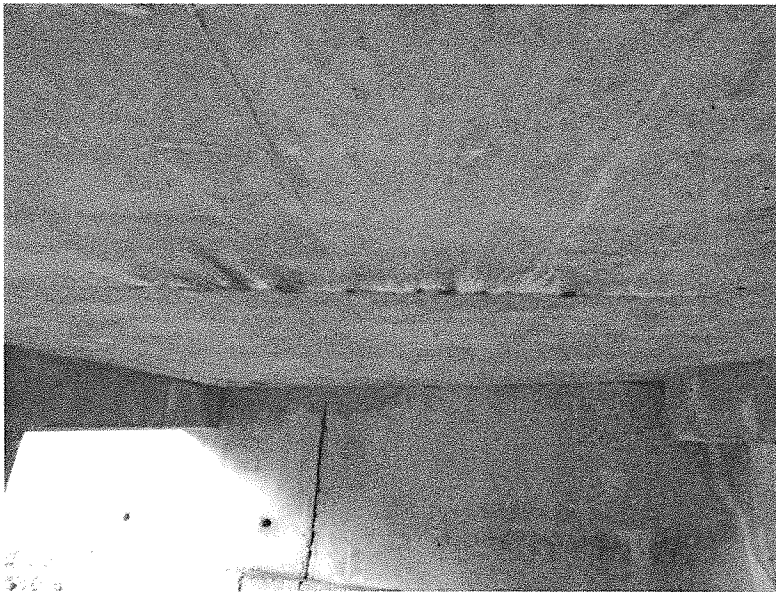
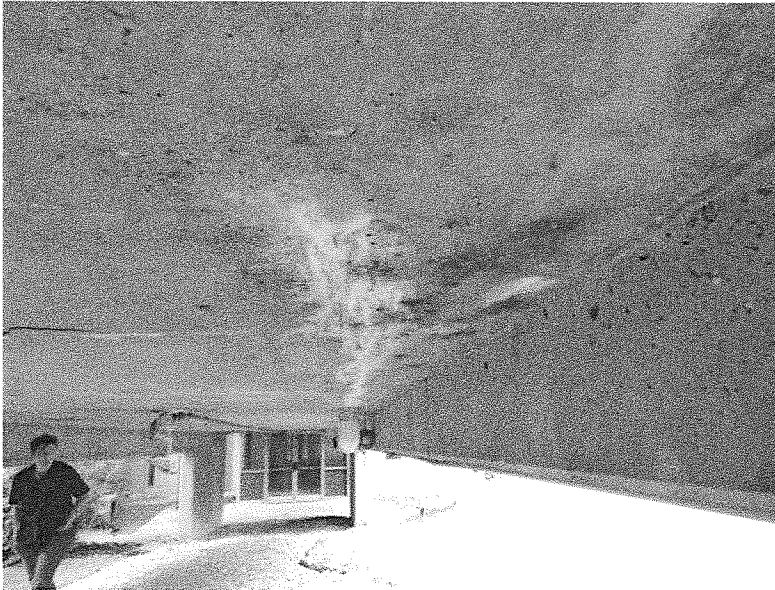
Figure 32. Cracks in concrete with efflorescence and corrosion staining at underside of pedestrian bridge

Figure 33. Cracks in concrete with efflorescence and corrosion staining at underside of pedestrian bridge

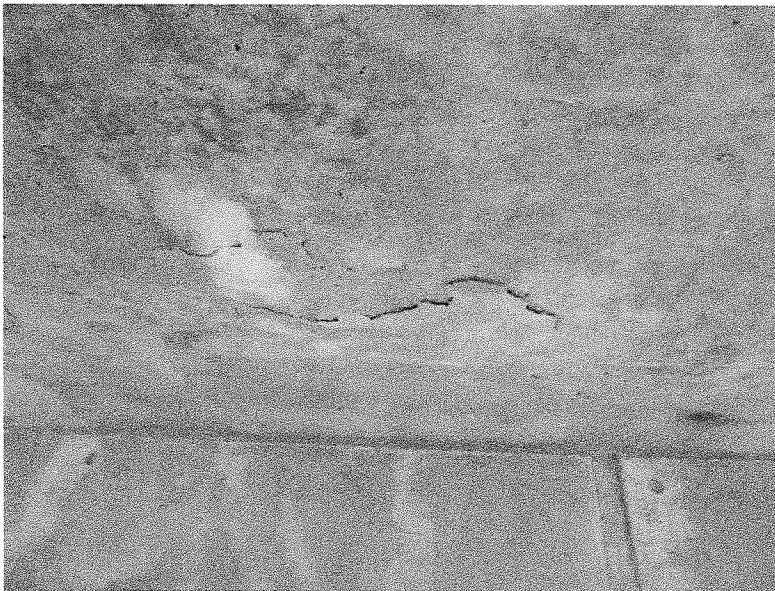
Figure 34. Incipient spalls in concrete at underside of pedestrian bridge

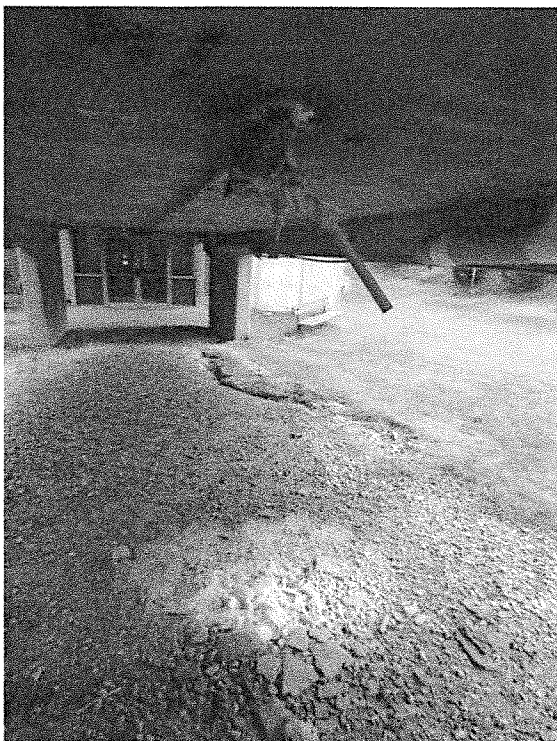
Figure 35. Efflorescence at penetration at underside of pedestrian bridge

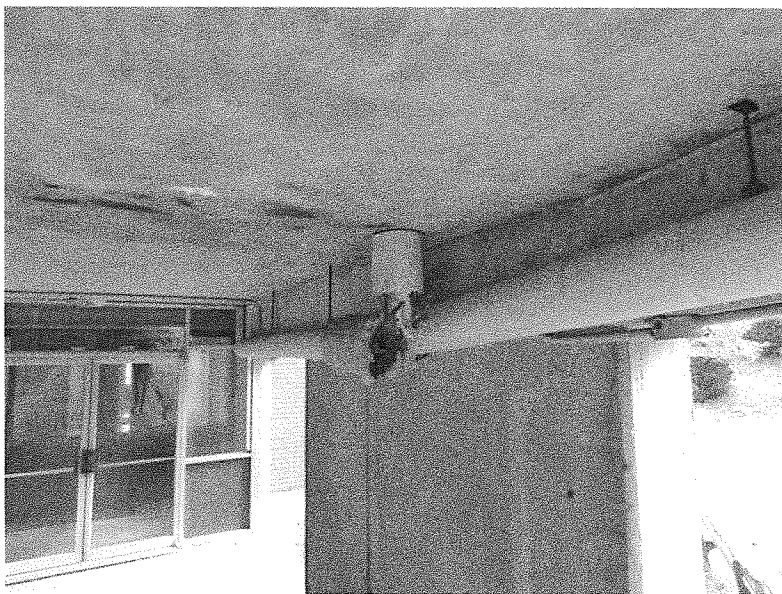
Figure 36. Broken pipe drain at underside of pedestrian bridge

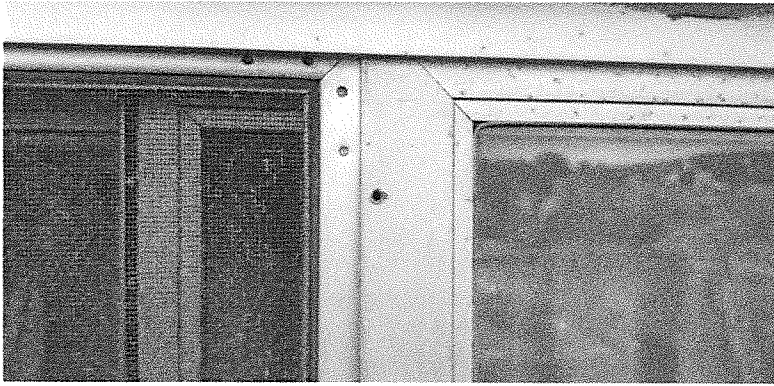
- Holes and missing fasteners are typical at window framing (Figure 37).
- Surface corrosion was observed of two frames at the first-floor north facade windows (Figure 38 and Figure 39).
- Glass is cracked glass at two of the first-floor windows (Figure 40).

Figure 37. Fasteners missing from window framing

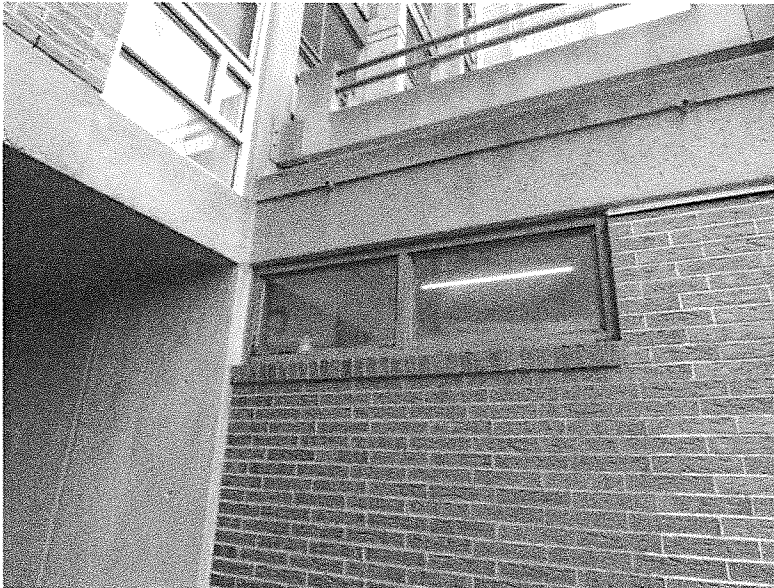
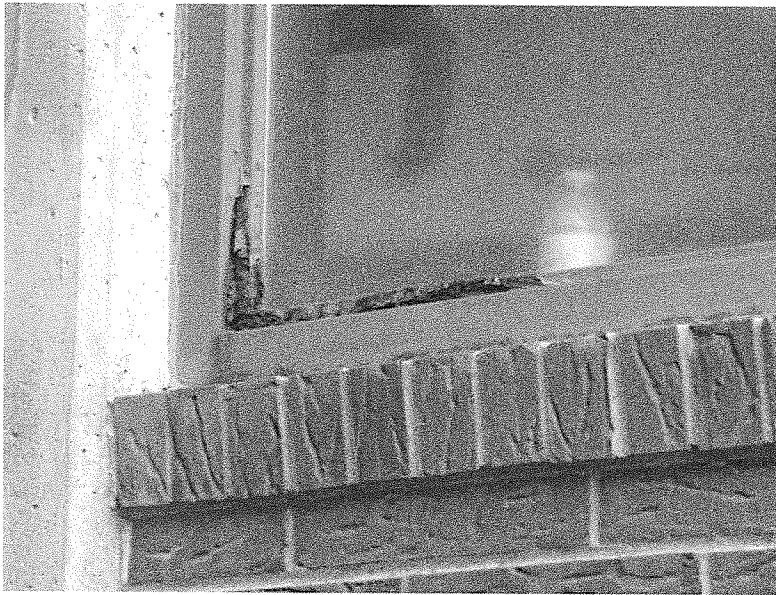
Figure 38. Corroded window frame at north facade, first floor

Figure 39. Corroded window frame at north facade, first floor

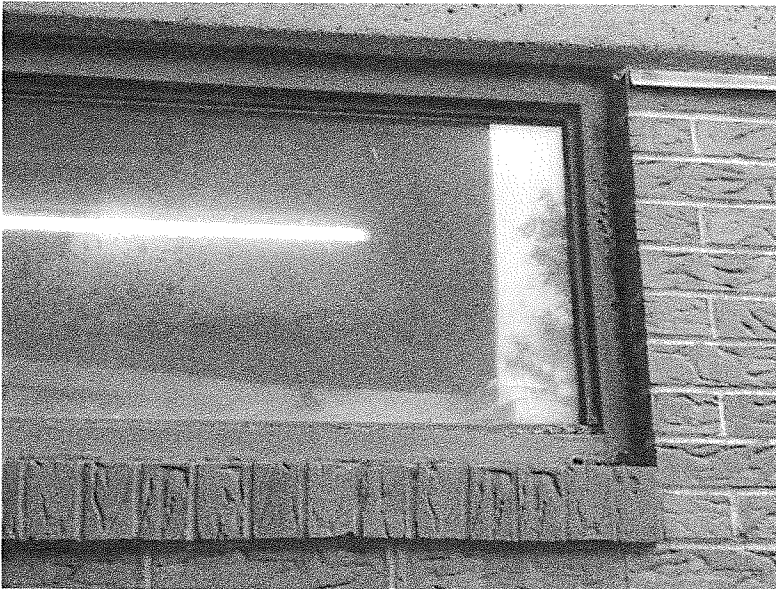
Figure 40. Cracked glass in window with corroded frame at north facade, first floor

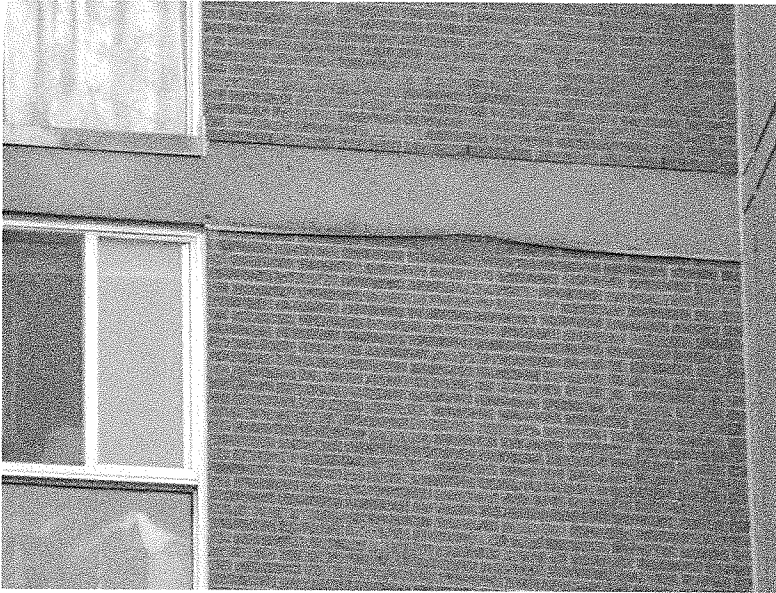
- Bent (approximately 10 feet) and displaced top of wall (concrete perimeter beam soffit) flashing at the eleventh-floor of the west facade (Figure 41).
- Window sill flashing includes upturned legs at the jambs. The upturned ends of the flashing are typically not regletted into the concrete at the column or mortar joint at the infill masonry wall, instead they are face-sealed to the substrate (Figure 42). In some locations, the mortar joints were cut but the upturned leg of the flashing is too short to be installed into the reglet (Figure 43).
- Displaced sill flashing was noted at one location at the west facade (Figure 44 and Figure 45).

Figure 41. Bent and displaced top of wall flashing at west facade, eleventh floor

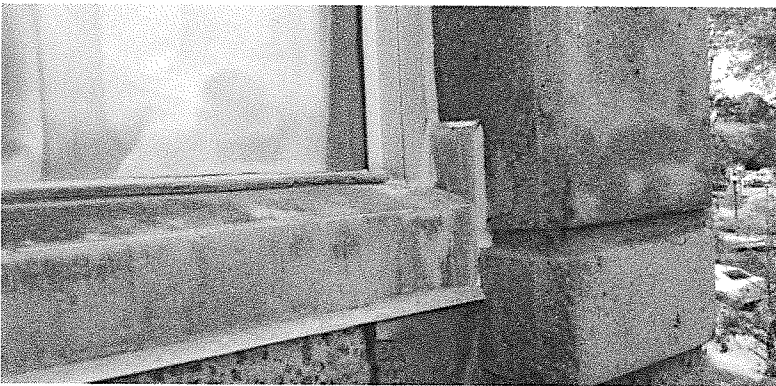
Figure 42. Upturned leg of window sill flashing face-sealed to substrate and not recessed into a reglet

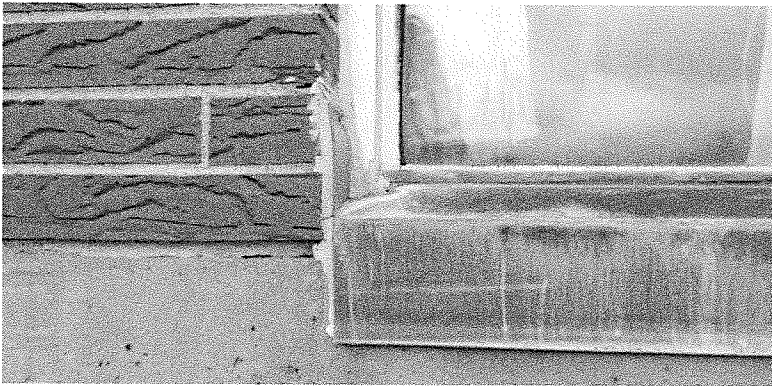
Figure 43. Cut mortar joint without embedded flashing

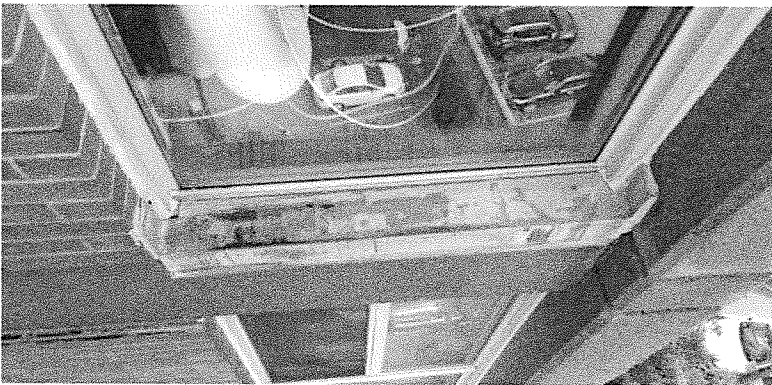
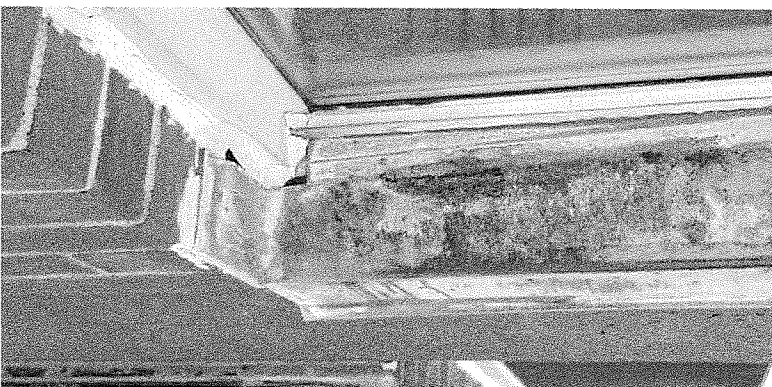
Figure 44. Sill flashing displaced at west facade

Figure 45. Sill flashing displaced at west facade

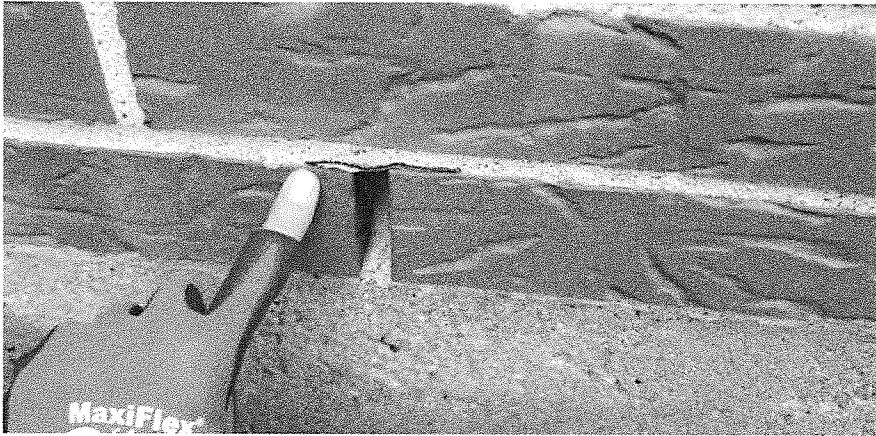
- An unidentified material, potentially flashing material or an exposed brick tie, was noted one course above floor line, above a weep (Figure 46).

Figure 46. Exposed material above weep hole in first course of brick above concrete floor line

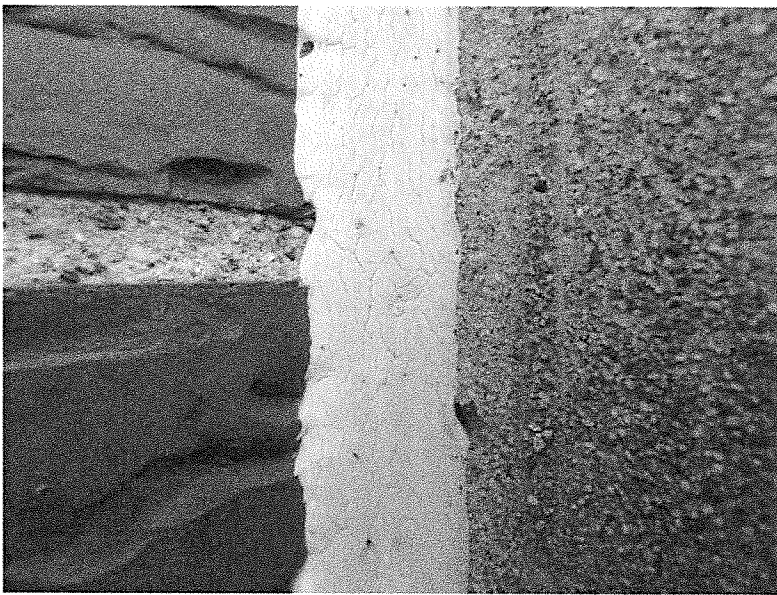
- Sealant is typically crazed, hard, and brittle (Figure 47).
- There is a missing sealant joint between the head and the underside of the lintel at one door perimeter at the north facade (Figure 48).
- Window perimeter sealant is typically failed cohesively and/or adhesively (Figure 49 and Figure 50).
- Layers of sealant were noted in many locations (Figure 51).

Figure 47. Crazed, hard, and brittle sealant in corner joint at west facade

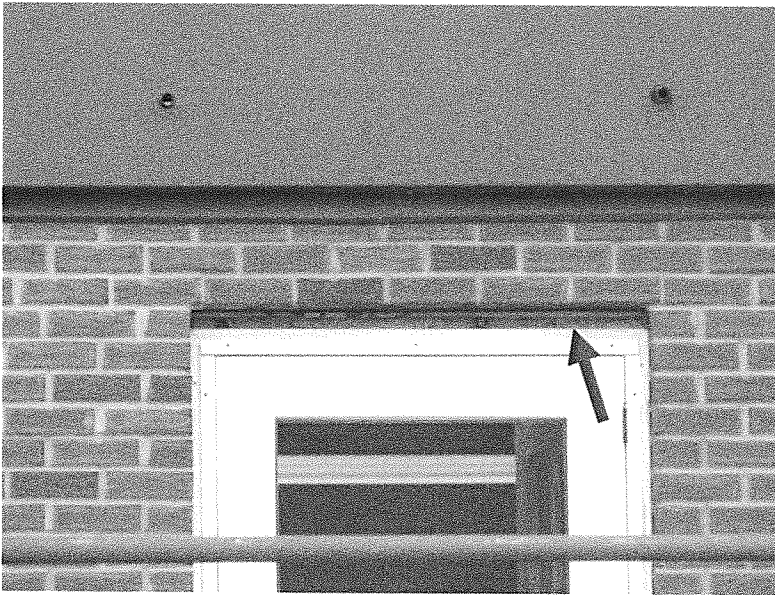
Figure 48. Missing sealant joint above door at north facade

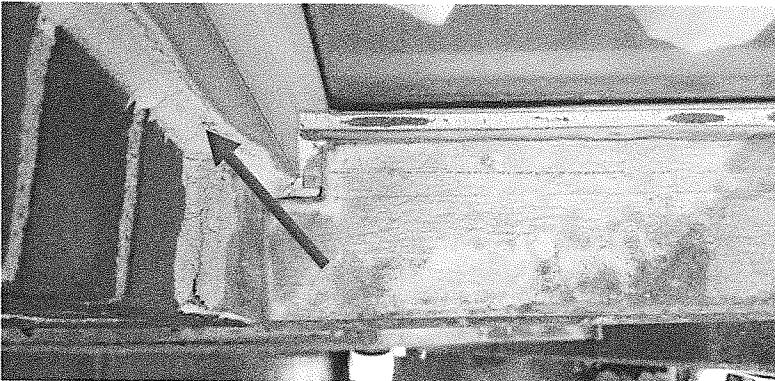
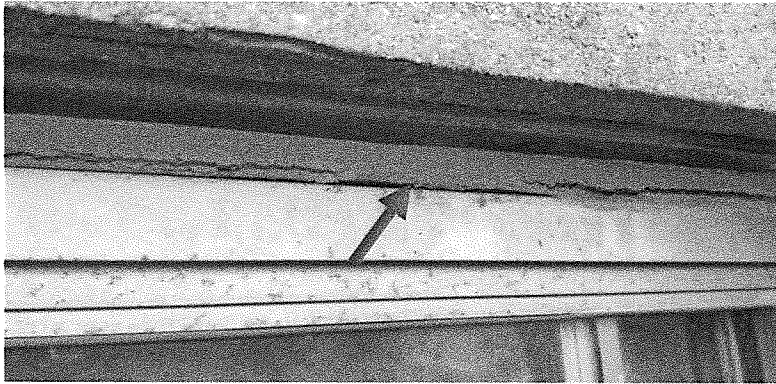
Figure 49. Window perimeter cohesive sealant failure at west facade

Figure 50. Window perimeter adhesive sealant failure at west facade

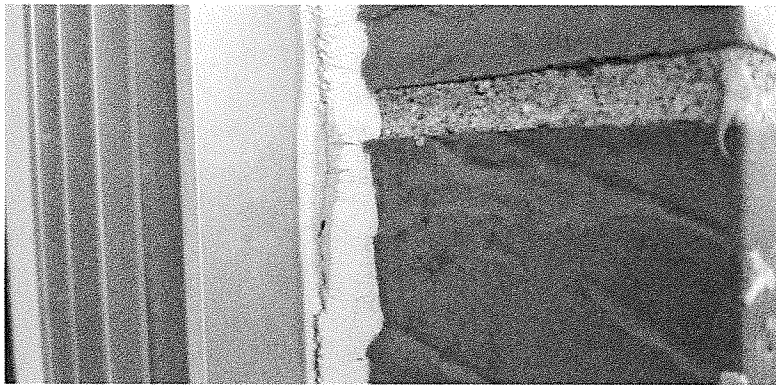
Figure 51. Multiple layers of installed sealant

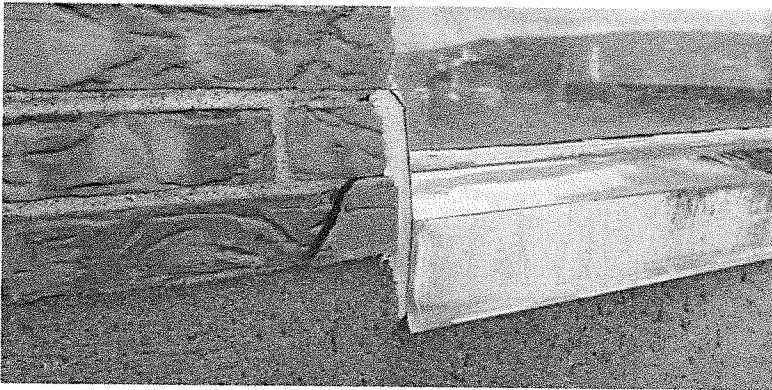
The second test was performed at the sill flashing and adjacent damaged brick veneer (Figure 55). Water was sprayed from slightly below the flashing. Water was observed at the interior at the floor immediately below the sill after approximately five minutes of testing (Figure 56). Parquet flooring was removed to better observe the water infiltration (Figure 57). Water continued to enter at the floor line of Unit 1102 even after the water was shut off.

Figure 55. Location for water testing of sill flashing and brick veneer

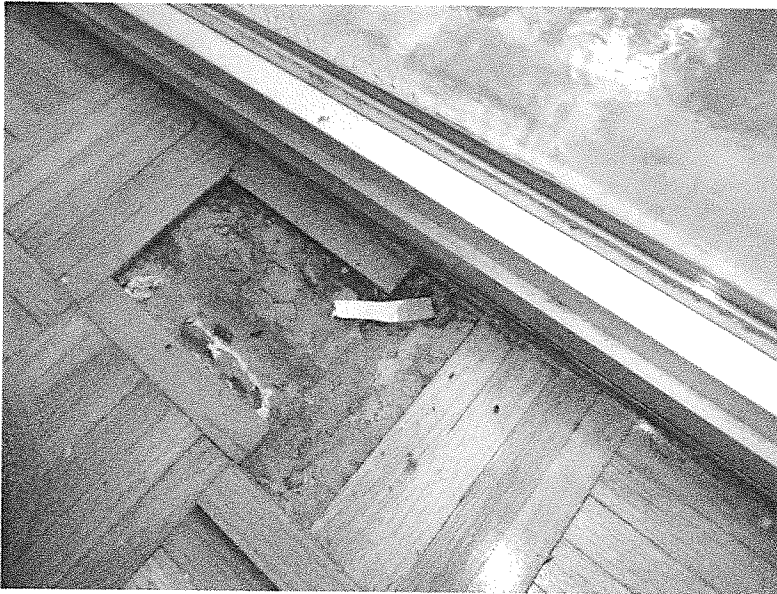
Figure 56. Water infiltration below window sill in bedroom of unit 1102 (indicator paper turns pink upon water contact)

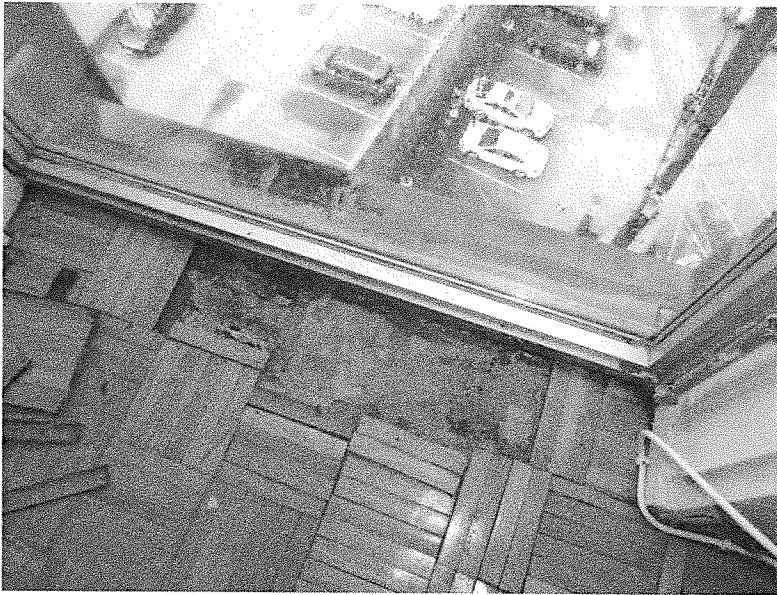
Figure 57. Removal of parquet flooring at leak location in bedroom of unit 1102
